## U.S. Coast Guard Research and Development Center

Report No. CG-D-02-07

## An Evaluation of the Potential Failure Modes for Gaseous Agent Fire Extinguishing Systems Installed within the Protected Space

FINAL REPORT
February 2007

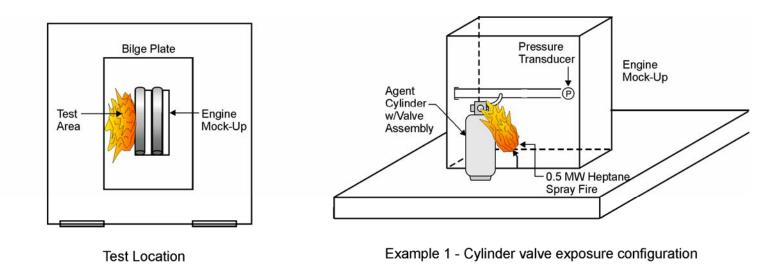
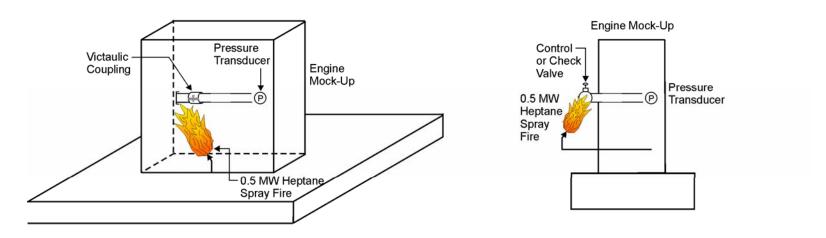
Example 2 - Victaulic coupling exposure configuration

Example 3 - Valve exposure configuration

In a majority of the cases, the breakdown of the system was caused by the failure of a plastic or rubber component or subcomponent. For example, the O-rings in the halocarbon cylinder valves, the gasket in the Victaulic coupling and the outer shell of the flex hoses were vulnerable to these types of exposures. Smaller parts with less mass to distribute the heat and parts with exposed rubber tended to fail the quickest. Rubber flex hoses were particularly susceptible to failure due to the large area of rubber exposed to the heat source and the ignition of the outer jacket during the test.

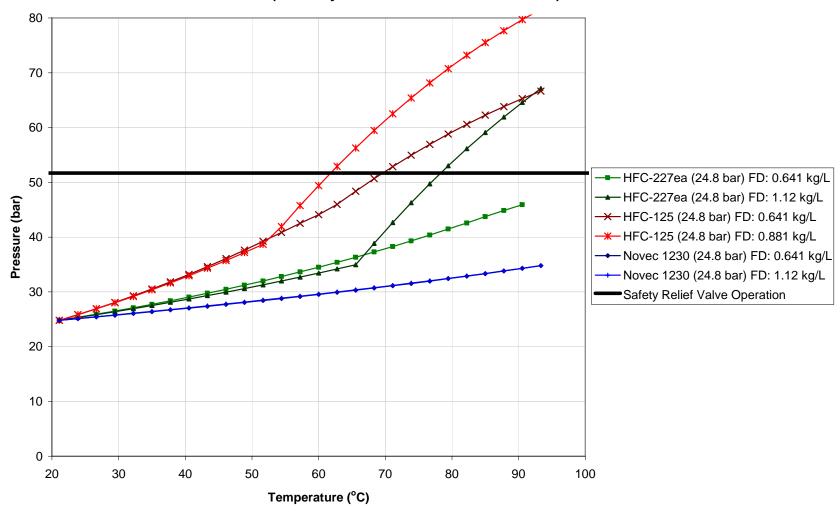
Figure 6. Agent Cylinder Pressure versus Temperature (Low Pressure Cylinders).

pressures. As can be seen from these figures, the temperature at which the safety relief valve would be expected to operate ranges from a low of 63 °C to a point where the 93 °C maximum temperature included in these figures is not close to causing the relief valve to operate.

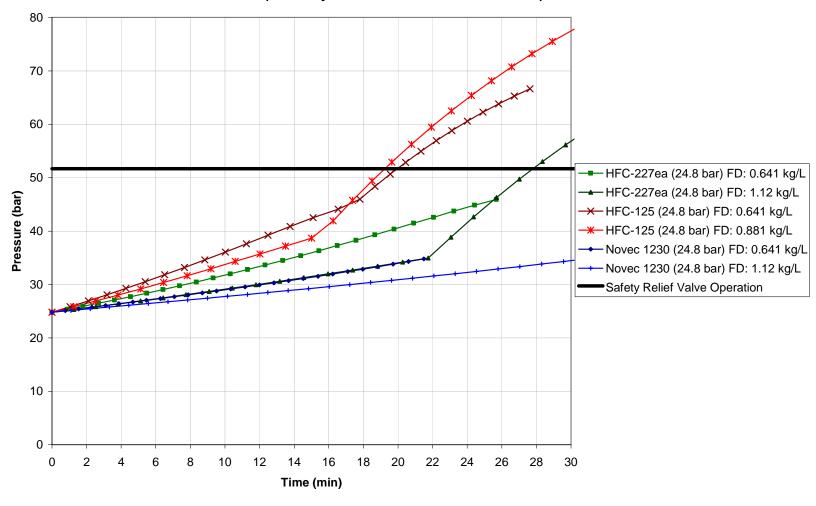
Figure 8. Agent Cylinder Pressure versus Time (Low Pressure Cylinders).

In order to estimate the exposure time to the fire environment before the operation of the safety relief valve, two simplistic heat transfer models were utilized. The first model utilizes a constant uniform heat flux to half of the surface area of the cylinder and neglects any developed temperature gradient through the cylinder (lumped heat capacity). This simulates the radiant heating of the cylinder from a fire. The estimated time to safety relief valve operation with an imposed heat flux of 15 kW/m² is given in Figures 8 and 9 for the low and high-pressure cylinders respectively. As can be seen from these figures, the agent cylinders are able to withstand this exposure for at least 18 minutes prior to relief valve operation.

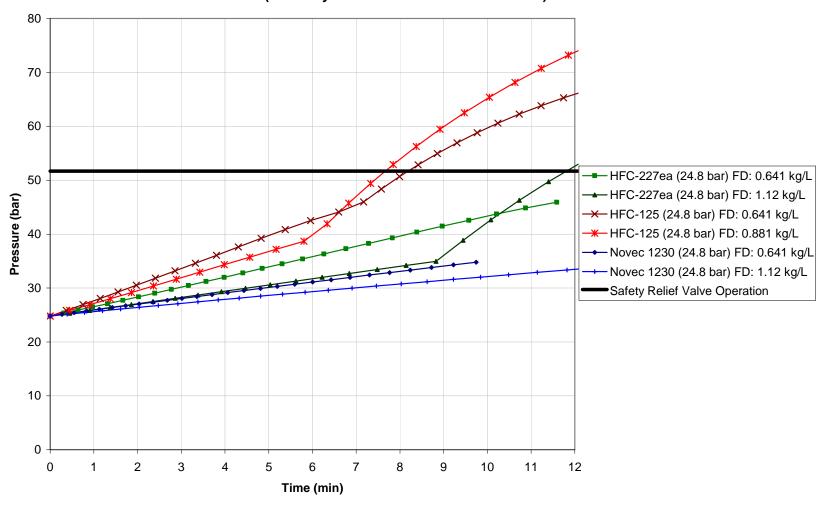
Figure 10. Cylinder Pressure with Constant Temperature Exposure of 200 °C (Low Pressure Cylinders).

The second heat transfer model utilizes a constant temperature exposure and estimates the cylinder response if immersed in the hot smoke layer formed within the space. This simplistic model utilizes a constant temperature exposure of 200 °C and a convective heat transfer coefficient of 59.6 W/m² °C. The estimated times for safety relief valve operation under this scenario are given Figures 10 and 11. As can be seen from these figures, the time to failure is much lower in this analysis with the first cylinder burst disk rupturing at approximately 7.5 minutes.

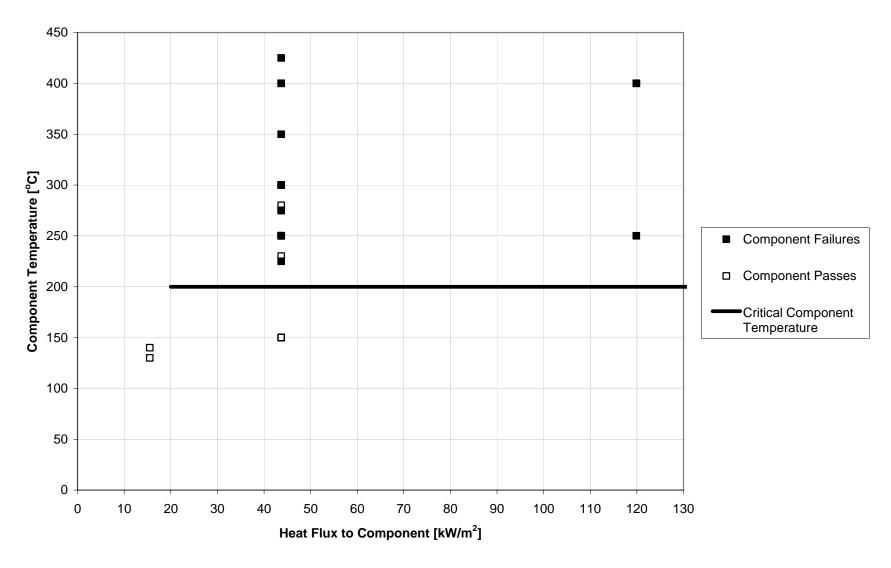
Figure 12. Critical Component Temperature.

The cylinder venting analysis suggests that the critical energy dosage for a radiant exposure is on the order of 16.2 MJ/m² but only about 6.8 MJ/m² for the convective (hot gas) exposure. As a result, the rubber components would fail prior to the venting of the cylinder when the exposure is caused by a radiant flux. However, for the hot gas exposure (immersion of the agent cylinder in the hot gas layer), the critical energy dosage required to cause the cylinder to vent its contents would be less than the critical value for the rubber components.

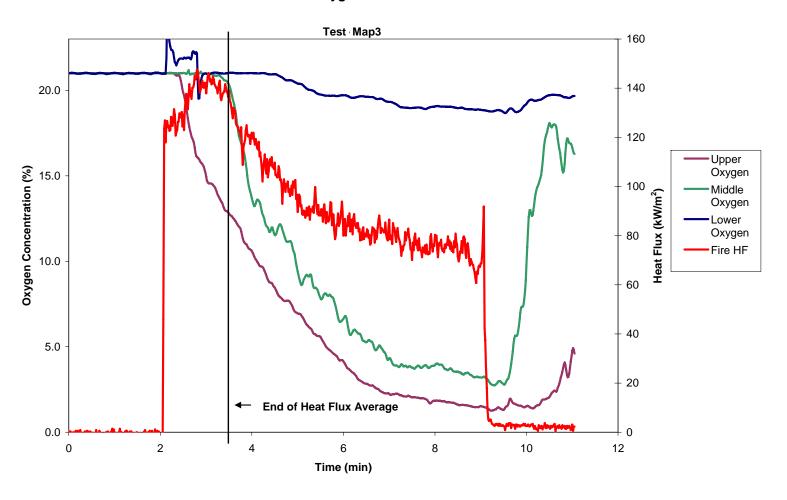
Figure 14. Oxygen Concentration and Heat Flux Plot for the 3.0 MW Fire.

The test conducted with the 3.0 MW spray fire was terminated seven minutes after ignition. Despite limiting the test to seven minutes, the heat fluxes measurements indicate that the diminished oxygen concentration in the space had a significant affect on the fire prior to securing the spray. To ensure that the average heat fluxes were calculated during the time period when the fire was at maximum capacity, the oxygen concentration measured at the same approximate elevation as the spray was analyzed. The time when the middle oxygen analyzer showed a significant drop in concentration was used as the final point in the heat flux average calculation. For the 3.0 MW spray fire, the middle oxygen concentration dropped off 1.5 minutes into the spray fire. The drop in concentration and the associated heat flux are shown in Figure 14.

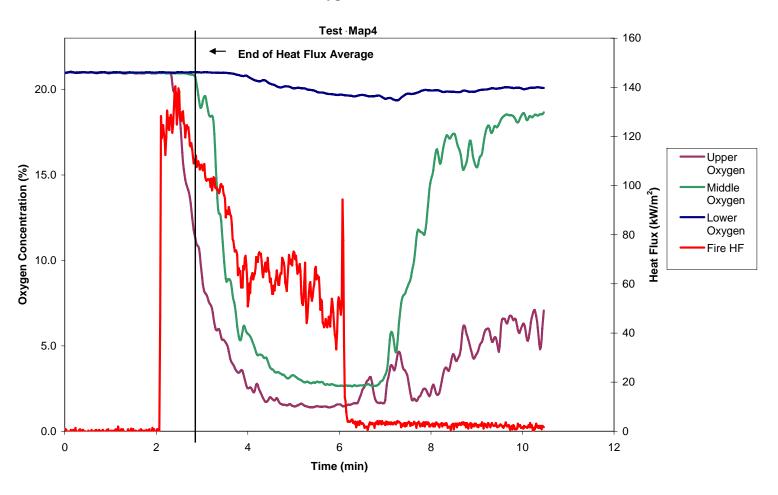
Figure 15. Oxygen Concentration and Heat Flux Plot for the 6.0 MW Fire.

The test conducted with the 6.0 MW spray fire had similar issues with the diminishing oxygen concentration as the 3.0 MW fire. The 6.0 MW spray fire was secured four minutes into the test. Once again, the middle oxygen concentration was used to determine the time period for calculating the average heat fluxes. For the 6.0 MW fire, the data was averaged starting 15 seconds after ignition for a period of 35 seconds (ending 50 seconds after the start of the spray fire). A graph of the oxygen concentration and heat flux is shown in Figure 15.

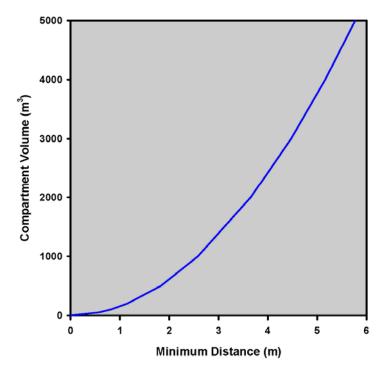
Figure 16. Minimum Safe Distance Between a Gaseous Agent Cylinder and a Fire as a Function of Compartment Volume.

As shown in Figure 16, the minimum safe distance between the fire and the cylinder increases with compartmental volume (as one would expect). This increase is related to the increased amount of oxygen available for combustion in the larger machinery spaces (i.e., the size of the fire required to consume the oxygen in ten minutes is larger for the larger spaces).

The minimum separation distance between cylinders is determined by multiplying the minimum safe distance by two. More specifically, the cylinders need to be spaced such that a fire located between two cylinders can only damage one of the cylinders.
